# KAJAKAI PROJECT GEOTECHNICAL WORK

**Date of Report:** August, 2006

**Project Title:** Geotechnical Close - Out Report

**Advanced Engineering Associates International, Inc.**

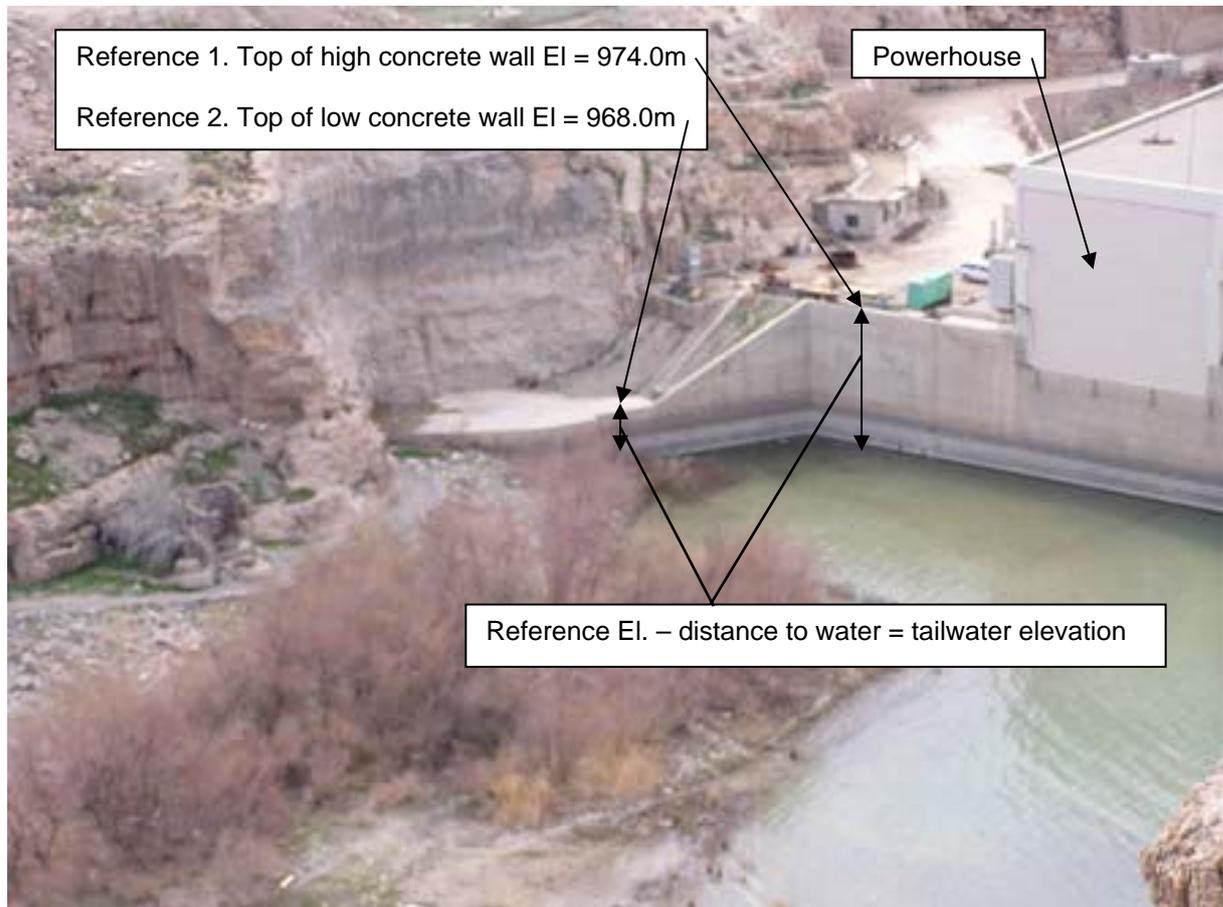
Tailwater levels are currently not being measured. Following is a photo which indicates locations from which direct measurements can be taken from known reference elevations to the tailwater surface for this determination. Such measurements may not be needed for routine operation. However, they would be necessary for significant spring/summer spillway overtopping events and when piezometer readings are taken.

Two convenient locations for measuring tailwater elevation on a minimum basis of:

- once per week
- each day of noticeable change, and
- each time piezometers are monitored
