SITE ASSESSMENT

SITE ASSESSMENT SURVEY

25 January 2011

GARM SER FOB DWYER ROADS AND RANGES, 215TH GARM SER DISTRICT, HELMAND PROVINCE, AFGHANISTAN
MACTEC PROJECT NO. 6144100221.05.0A.00031

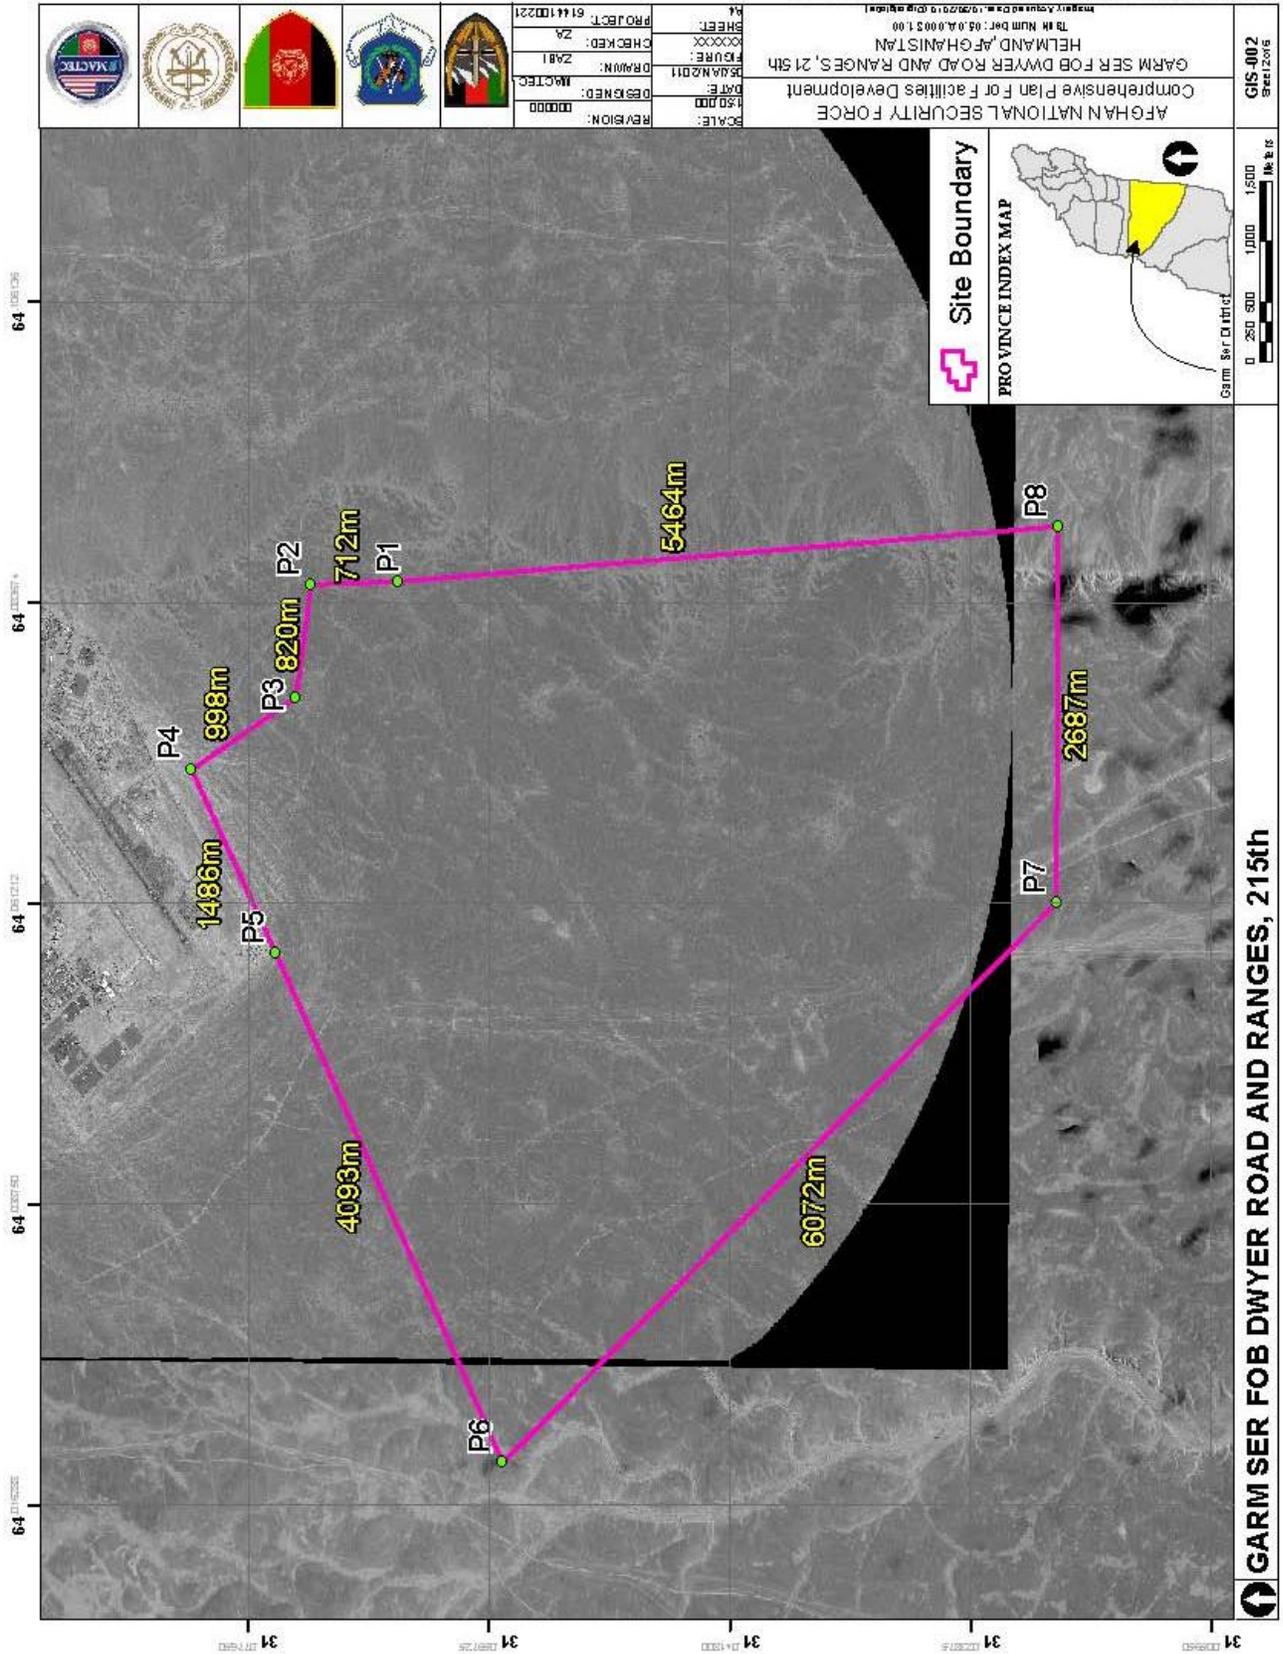
FIGURE 3 - SITE DIMENSIONS

A majority of the site is relatively flat with a relief of 5m from south to north. However, the southeast corner has a hill which rises approximately 10 meters.

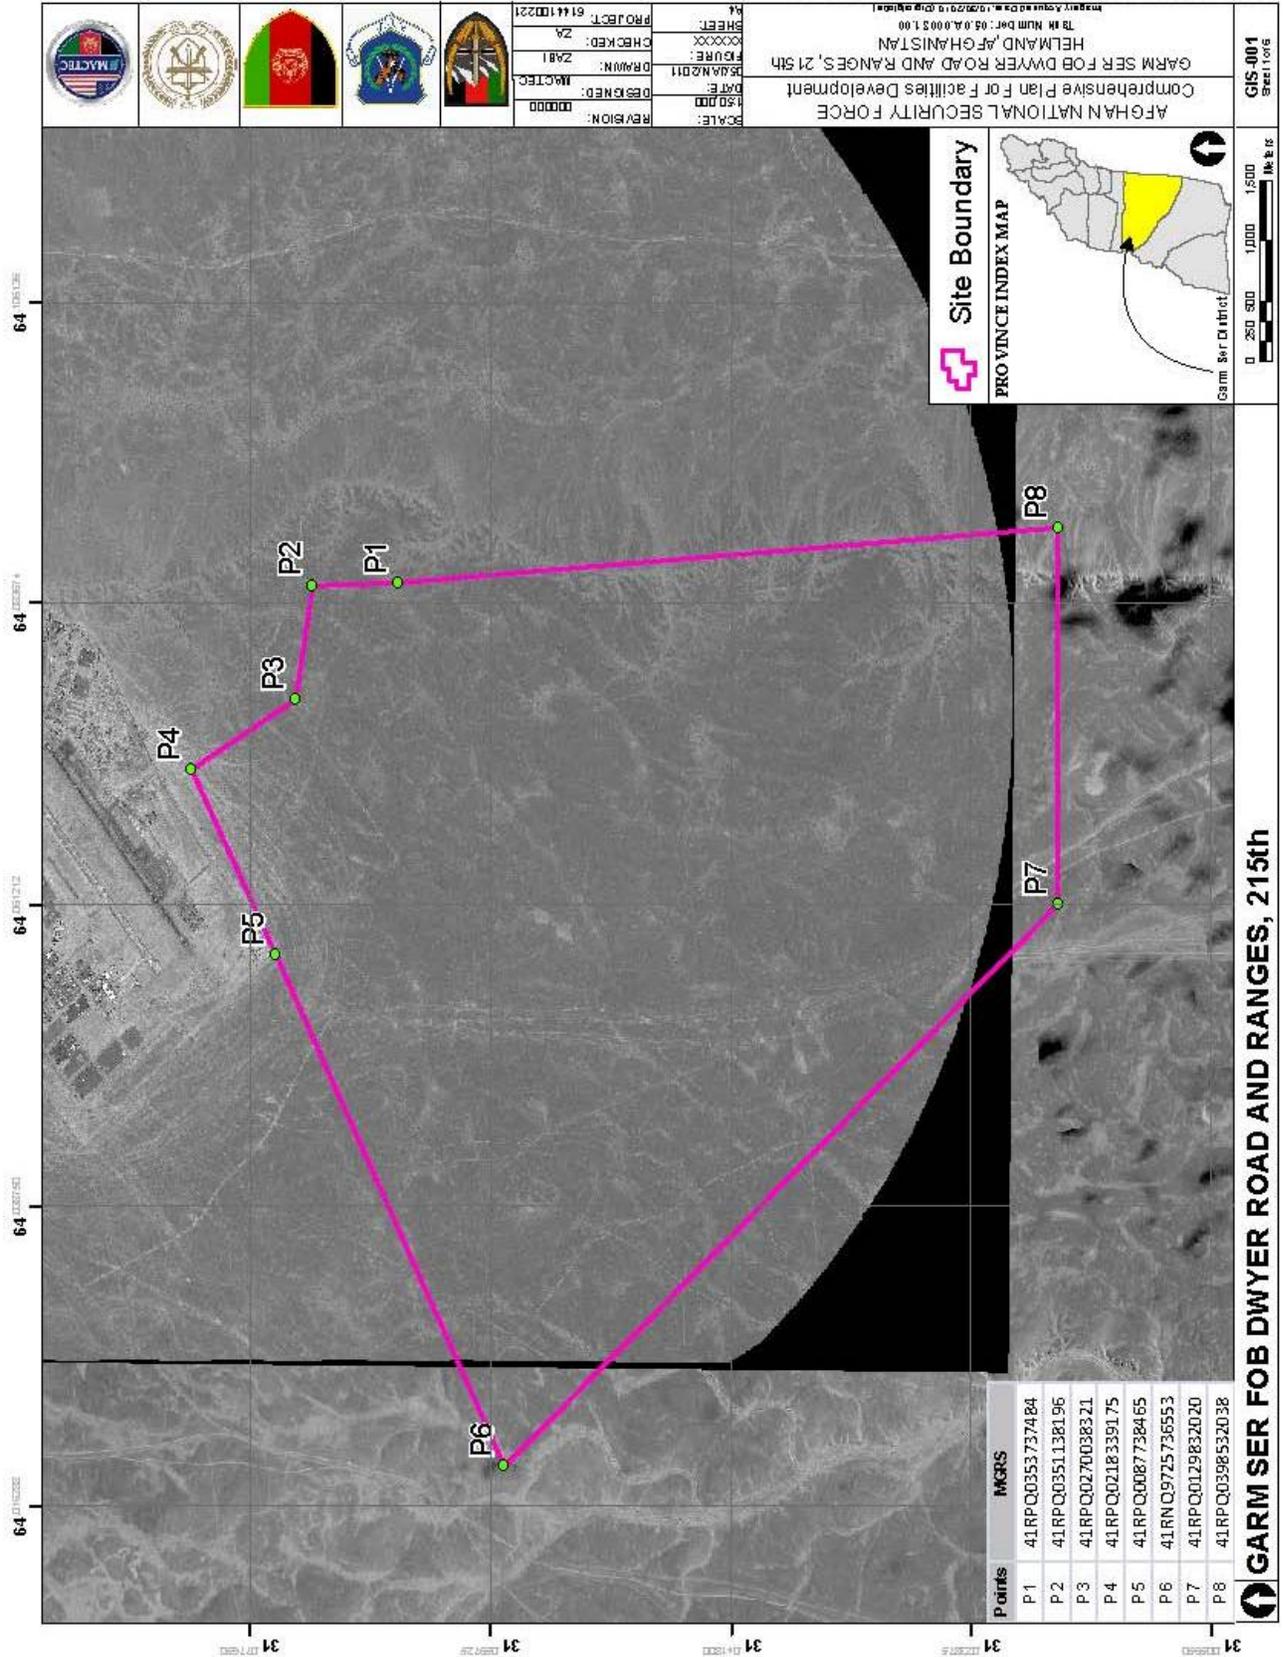
FIGURE 4 - SITE COORDINATES

Site Description	Site Location	Corner Point	MGRS	Elevation (m)
Garmsir FoB Dwyer Ranges 215 Th	Garmsir District, Helmand Province, Afghanistan	P1	41RPQ 03537 37484	651m
		P2	41RPQ 03511 38196	665m
		P3	41RPQ 02700 38321	651m
		P4	41RPQ 02183 39175	650m
		P5	41RPQ 00877 38465	649m
		P6	41RNQ 97257 36553	648m
		P7	41RPQ 01298 32020	654m
		P8	41RPQ 03985 32038	639m

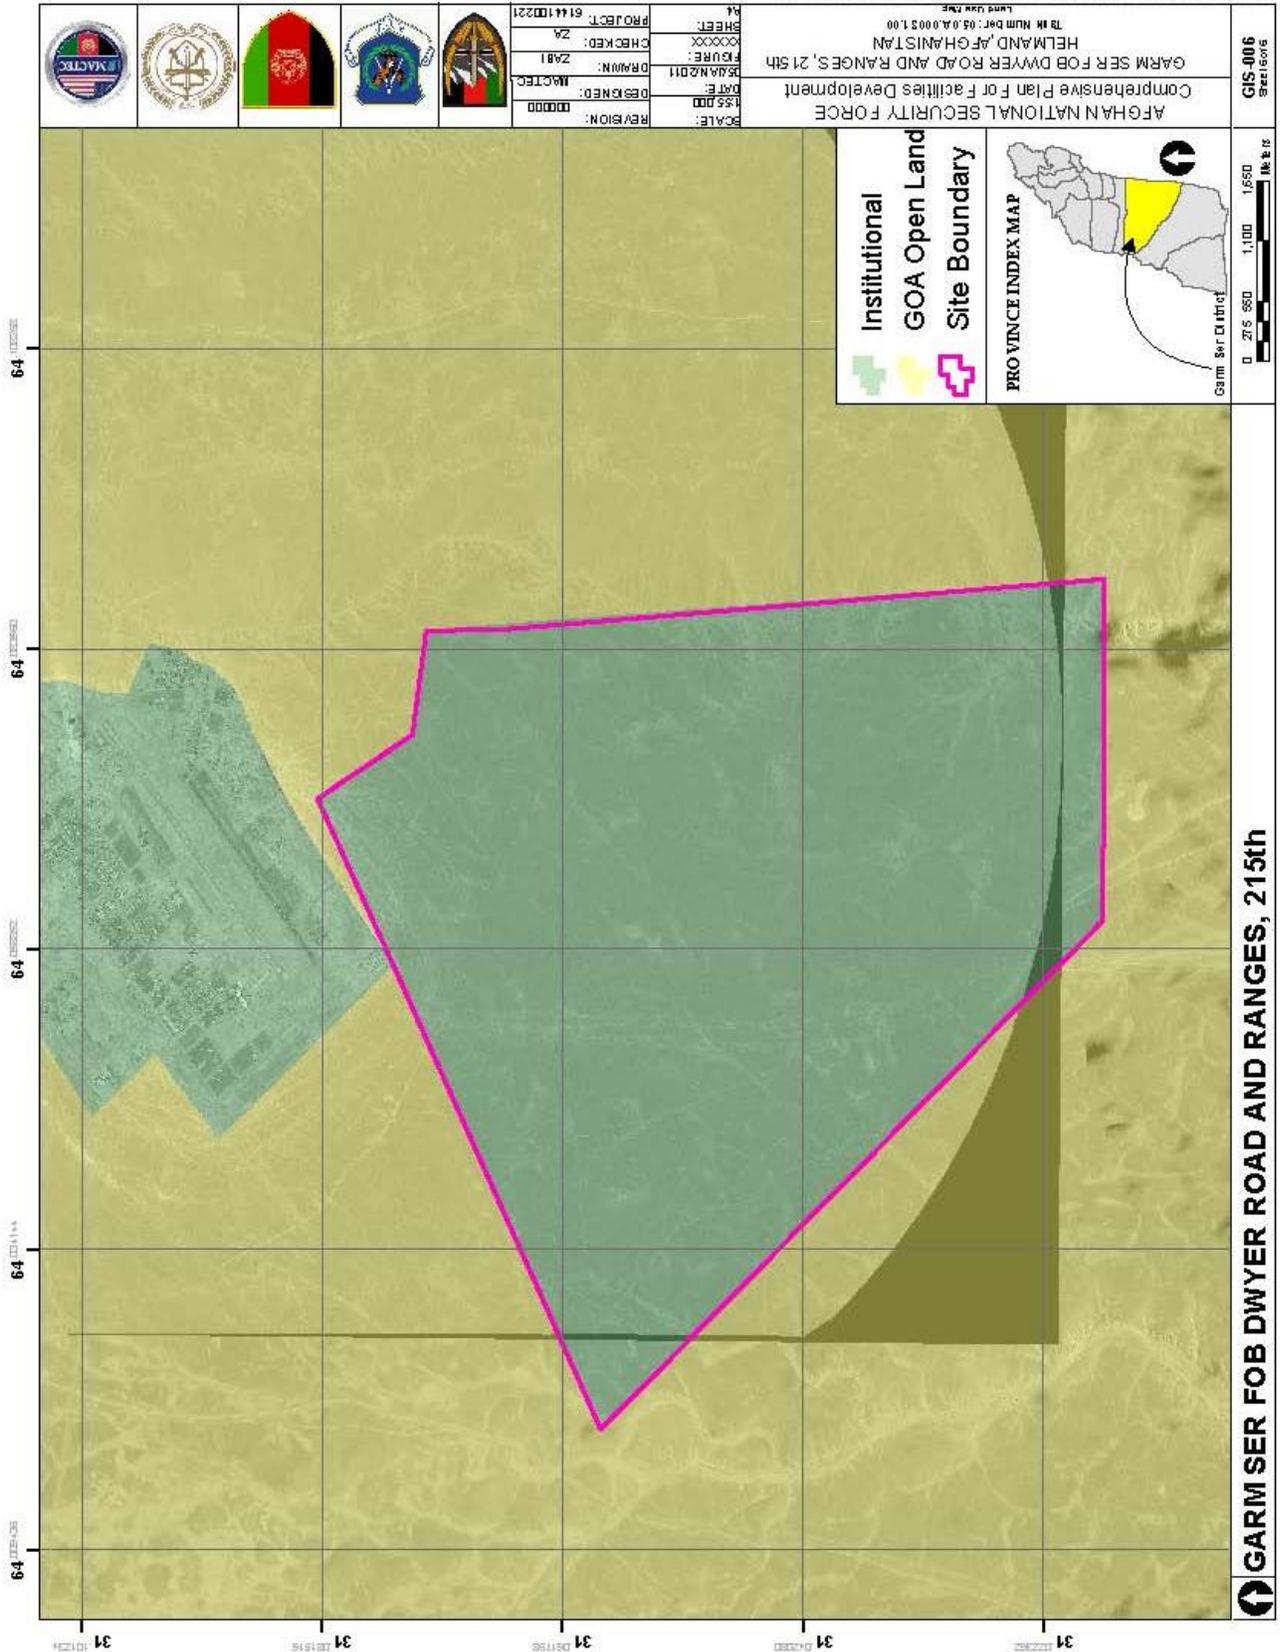
FIGURE 5 – LAND USE MAP

To the north, the site is bordered by Camp Dwyer. To the south, west and east is undeveloped desert.

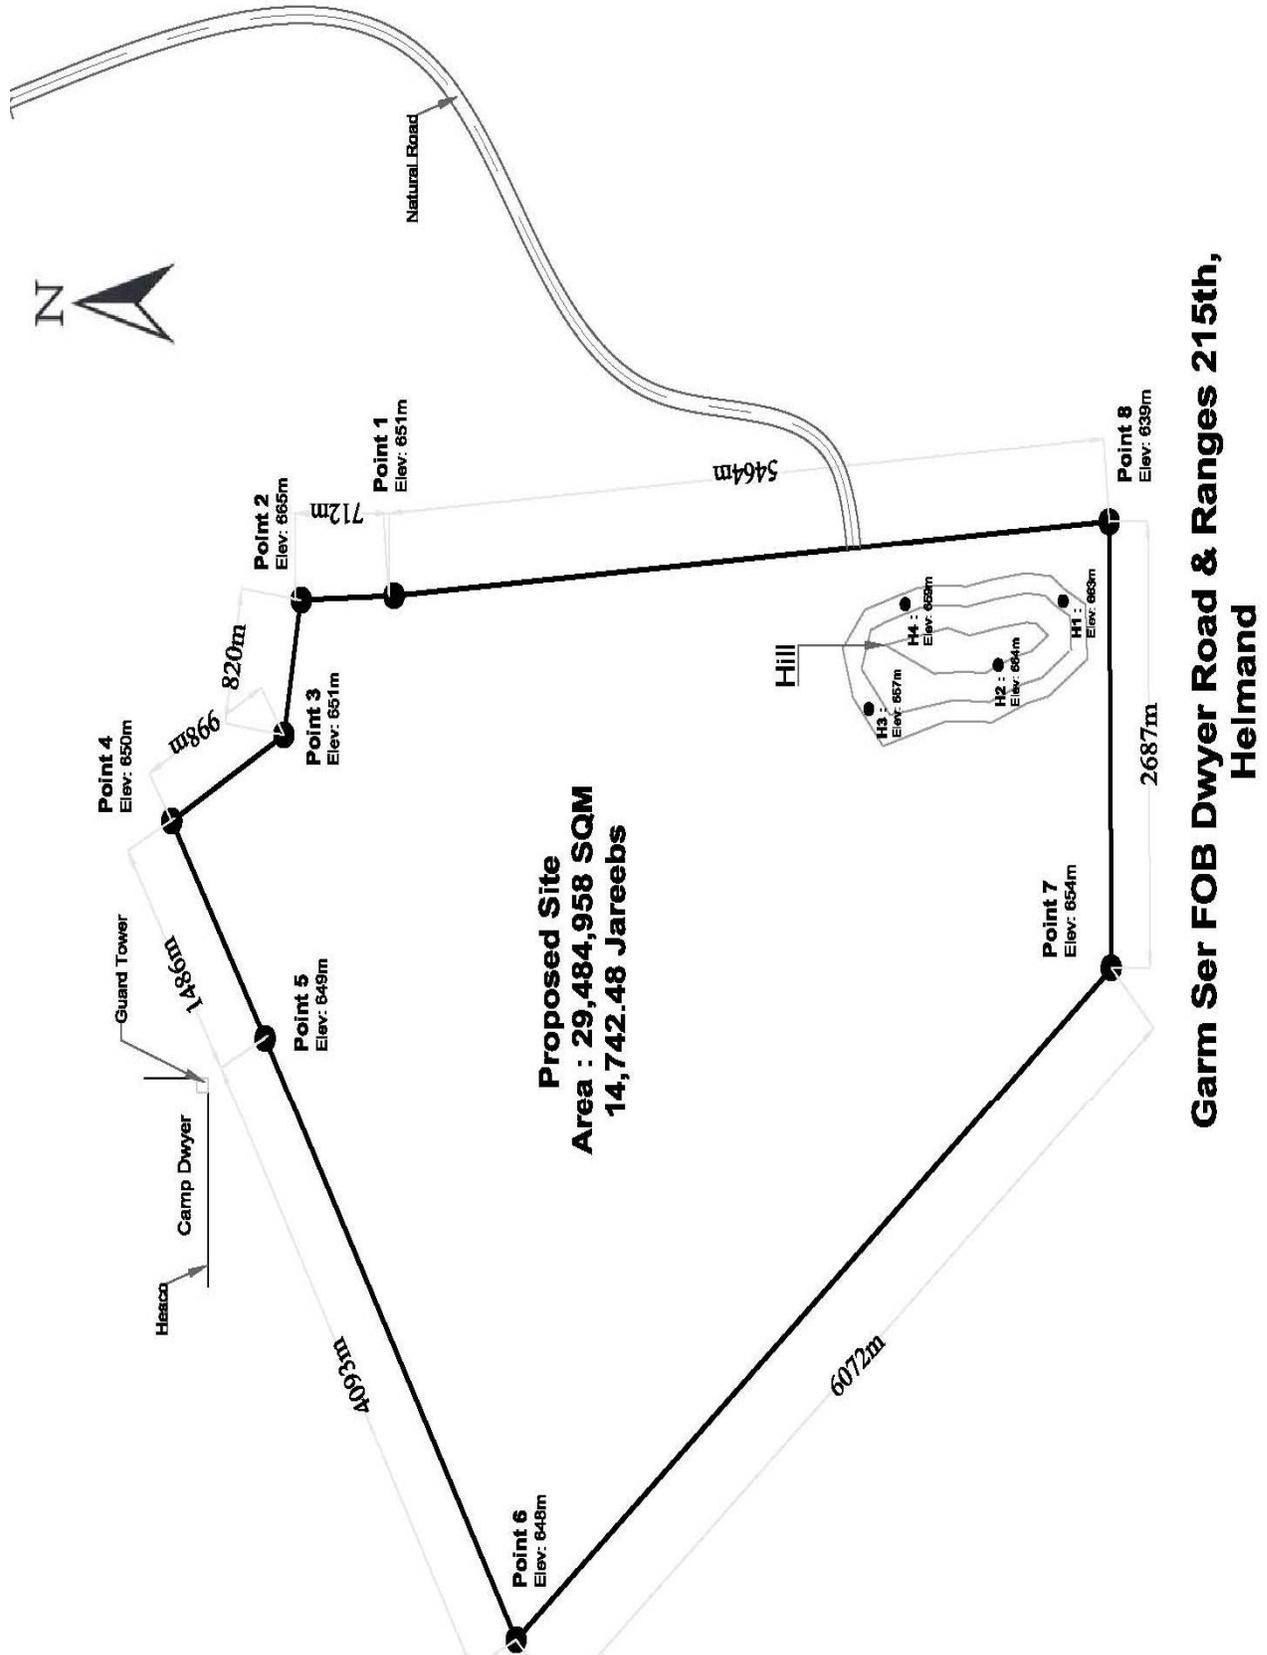
FIGURE 7 – EXISTING SITE SKETCH

The site currently is made up of unused desert and there are no existing structures within the identified parcel of land.
