# INSPECTION OF MECHANICAL FEATURES

## Helmand Valley
## Development Project

**AFGHANISTAN**

May 1964

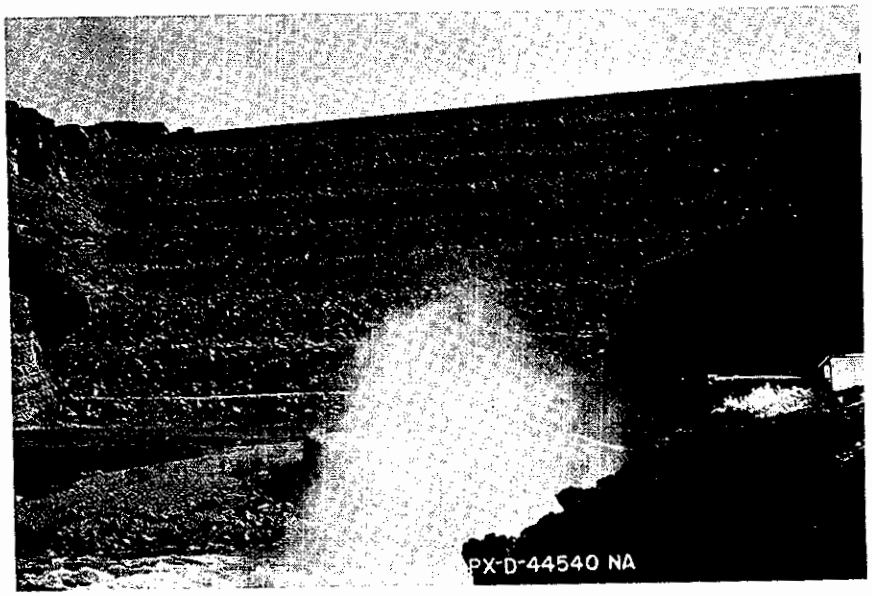
Figure 1.--Kajakai Dam. The downstream face of Kajakai Dam with the three 84-inch hollow-jet valves discharging 90 percent open.

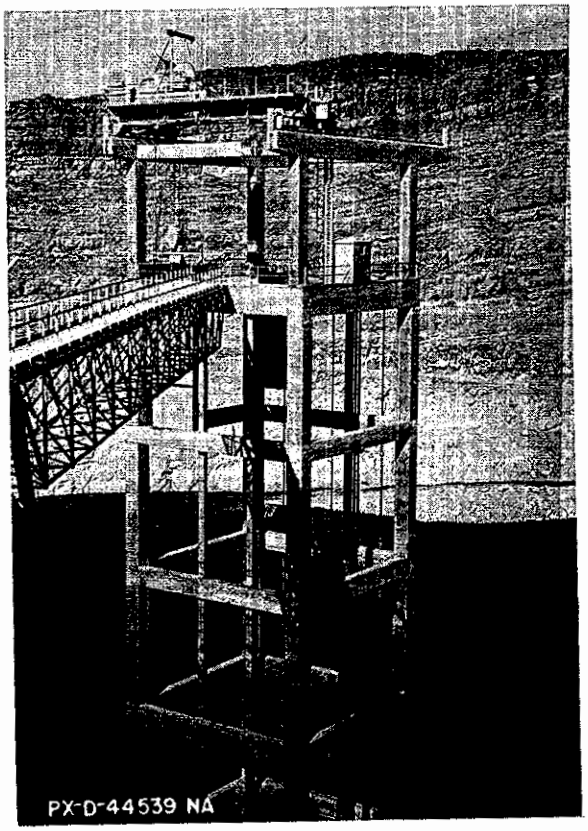
Figure 2.--Kajakai Dam. Open frame intake structure showing the walkway bridge, hoist, and intake gates in the storage position.

The concrete intake structure, access bridge, gantry crane, and all miscellaneous metalwork on the structure appeared to be in excellent condition. Equipment has been kept painted and generally clean. The wheel gate and bulkhead gate are kept in storage position on the gate structure, ready for use. The bulkhead is well painted and in good operating condition. The upstream side of the wheel gate is of open construction and the beam flanges form pockets that do not have drain holes. Accumulation of dirt, bird nests, and moisture in these pockets accelerates paint deterioration and rusting. Roller bearings are used on the wheel of the wheel gate. Indications are that grease has dried and hardened through the years as the wheels could not be turned by hand. None of the equipment on the gate intake structure has been used since the dam was constructed. Neither gate has ever been closed since initial installation, the trashracks have never been taken out for inspection, and the hoist has never been used.

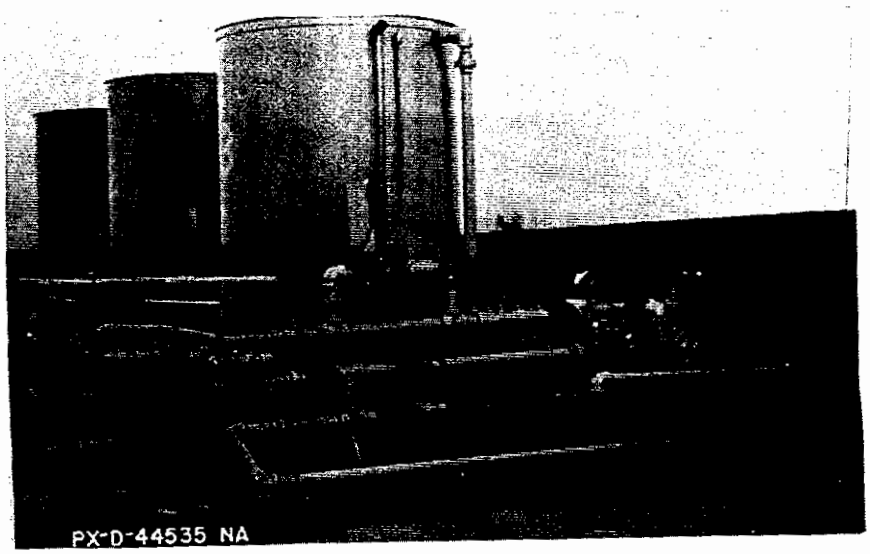
Figure 6.--Kajakai Dam. Hydraulic control units for the hollow-jet valves. Note the four-man pump handles for manual operation, and the number of hand valves on the piping system.

The control system consists of an electrically driven oil pump, a 600-gallon (2,274-liter) oil tank, a solenoid-controlled relief valve, a spring relief valve, a filter, and 10 handwheel control valves, as shown in Figure 6. The pushbutton stations and position indicator are located on the control panel at one end of the room and the hydraulic controls are at the opposite end.

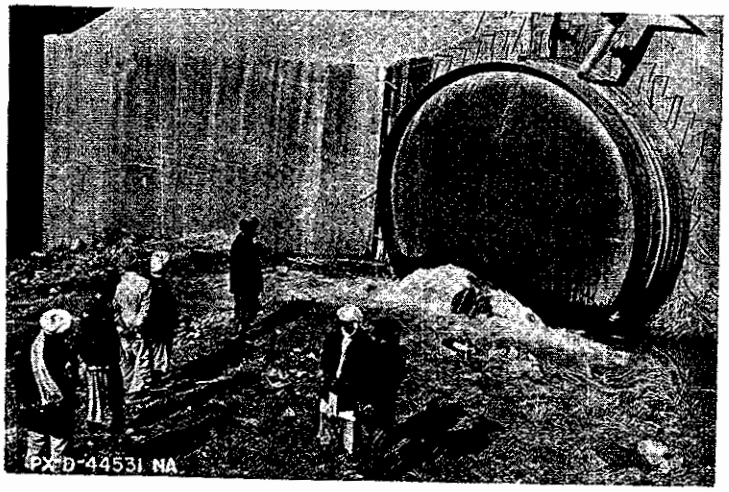
With the ring-follower gate open and the tunnel intake gate closed, the Howell-Bunger valves were opened to drain the tunnel. About half the tunnel drained through the Howell-Bunger valves, and the remaining water was drained by removing a 16-inch-diameter (41-centimeter) cover from the penstock bulkhead. The 48-inch-diameter (122-centimeter) outlet pipes were in excellent condition; there was no evidence of cavitation, erosion or

Figure 10.--Arghandab Dam penstock bulkhead. Draining the tunnel through a 16-inch-diameter manhole cover.

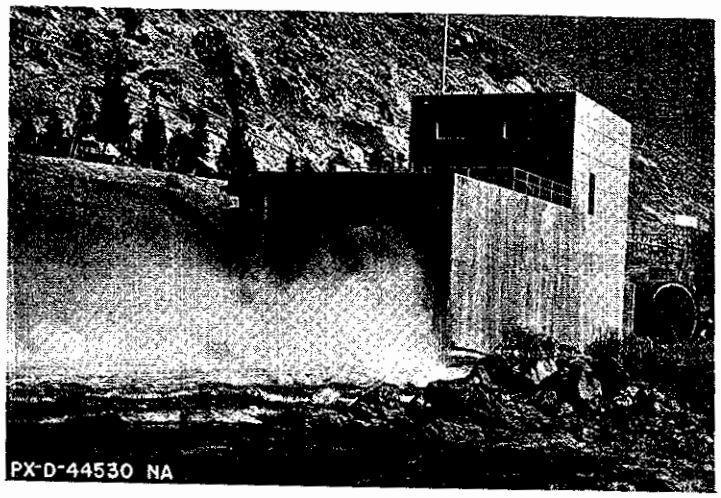
Figure 11.--Arghandab Dam. The valve house with the Howell-Bunger valves discharging at 30 percent opening.

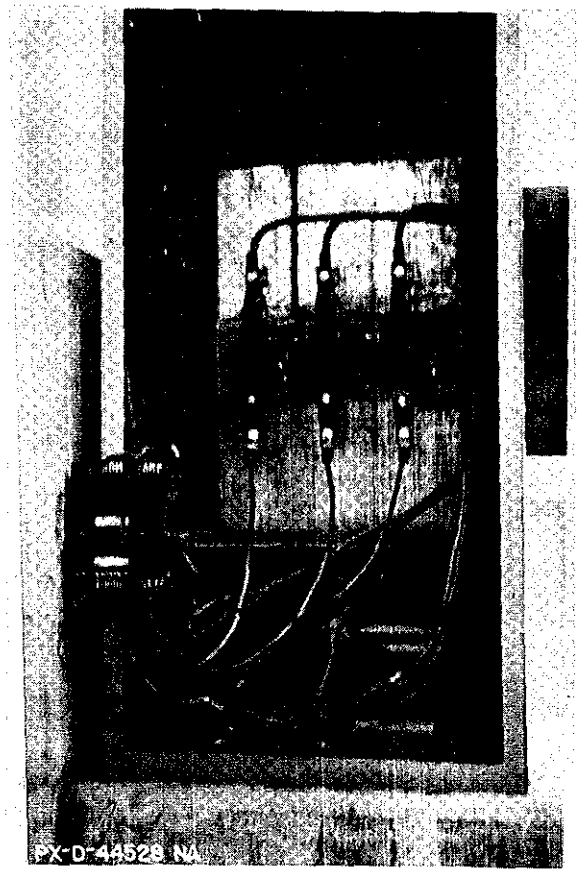
The turbine generator had been shut down for repairs, and wicket gate linkage adjustments. Part of the linkage used for hand operation has been damaged by too much force applied on a manual operating handle. The runner vanes are cavitated and need to be repaired. The back cover of the generator control cabinet is missing, and exposed switches and wiring are dangerous. Panel gages are damaged and out of adjustment.

Figure 13. --Arghandab Dam. The back cover of the turbine generator unit control cabinet has been removed for convenience of additional wiring.

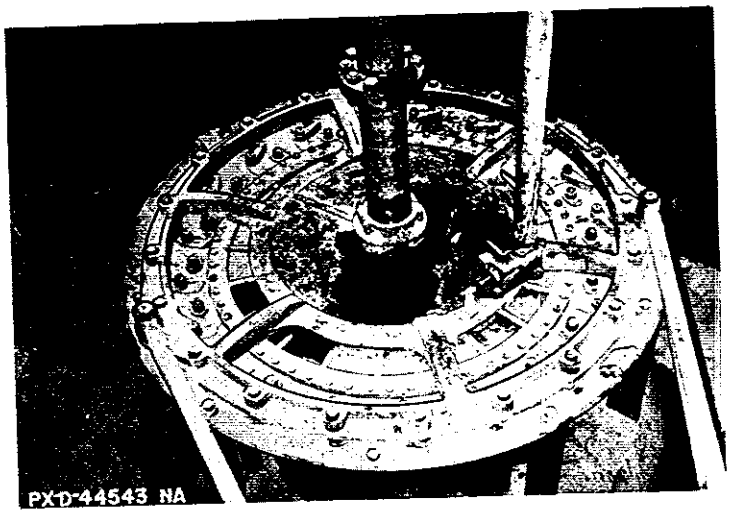
Figure 17. --Girishk Powerplant Unit 2. Top view of turbine showing the speed ring, turbine shaft and lower shaft coupling.

Figure 18. --Girishk Powerplant Unit 2 turbine runner. Edges of blades show wear from dragging on the lower crown ring.

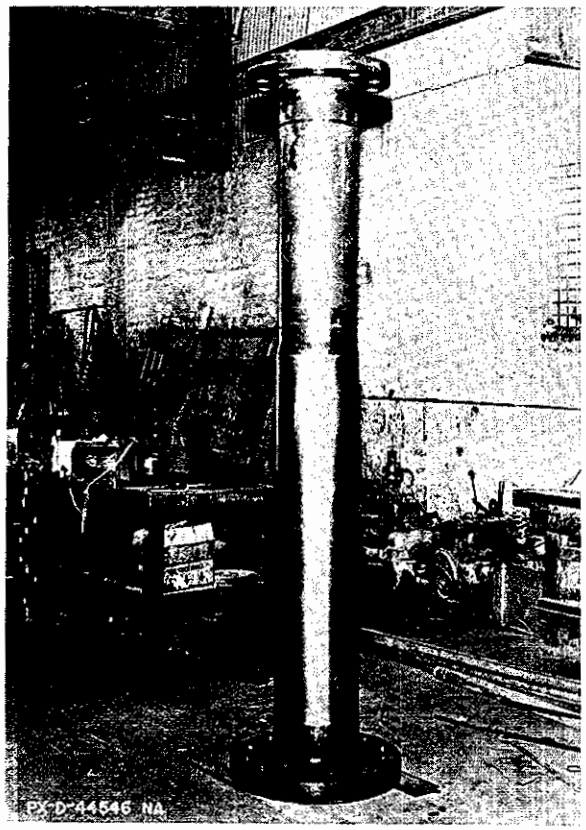
Figure 21. --Girishk Powerplant Unit 2. Turbine shaft after machining undersize to eliminate grooving. Shaft will be used temporarily while Unit 1 is shut down for examination.

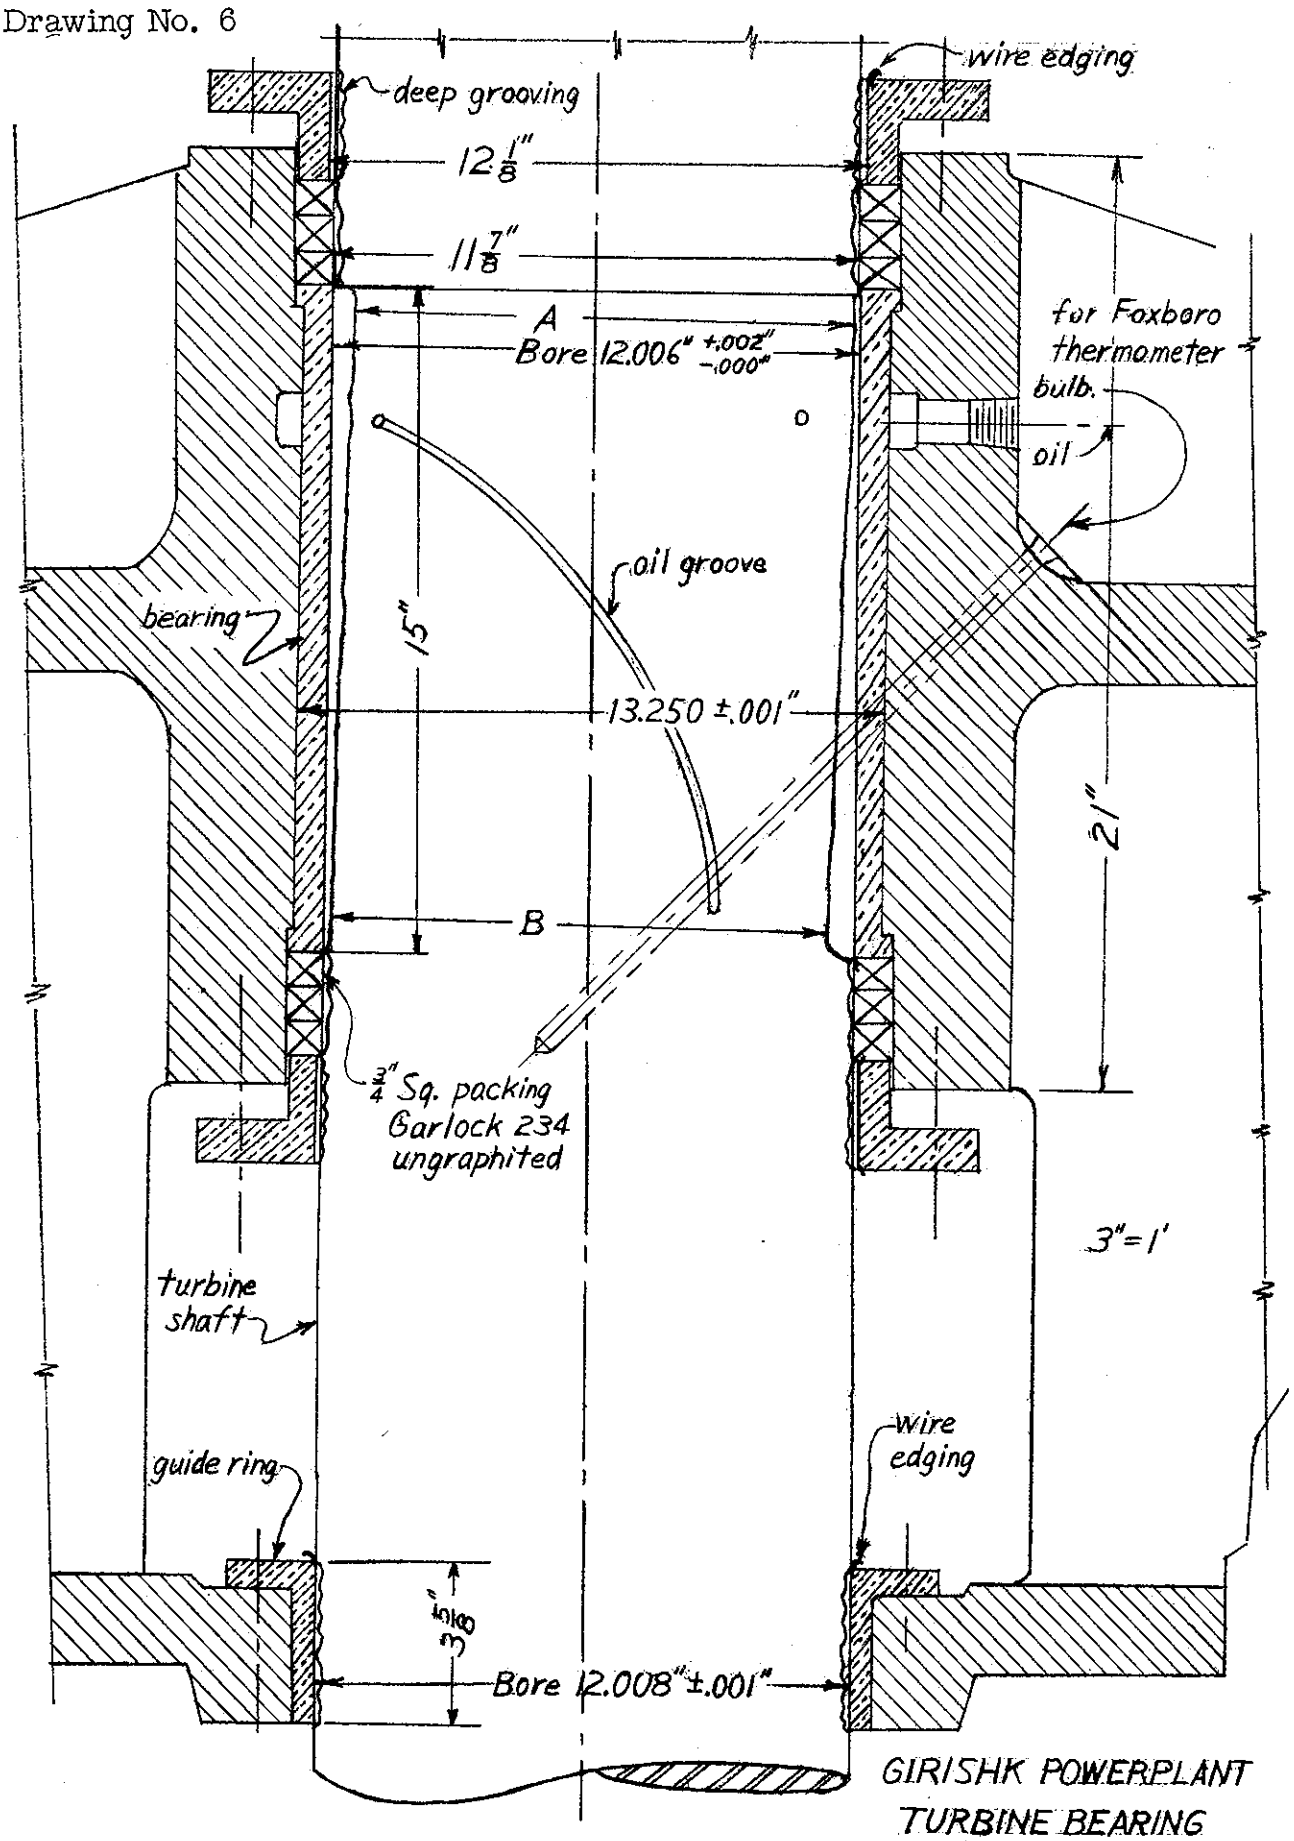
Figure 22. --Girishk Powerplant Unit 1. The turbine shaft bearing bracket assembled on the floor to measure the bearing diameter.

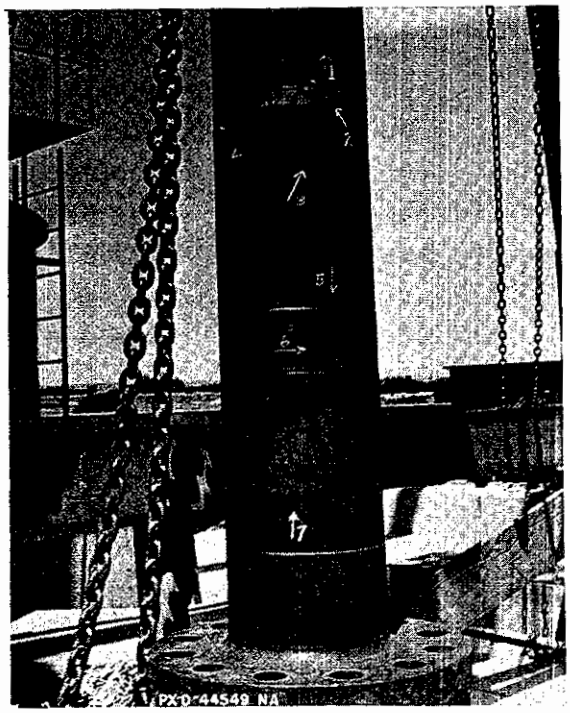
Figure 25. --Girishk Powerplant Unit 1. Turbine shaft bearing area showing severe worn surfaces. Area between 2 and 5 is the main bearing area.

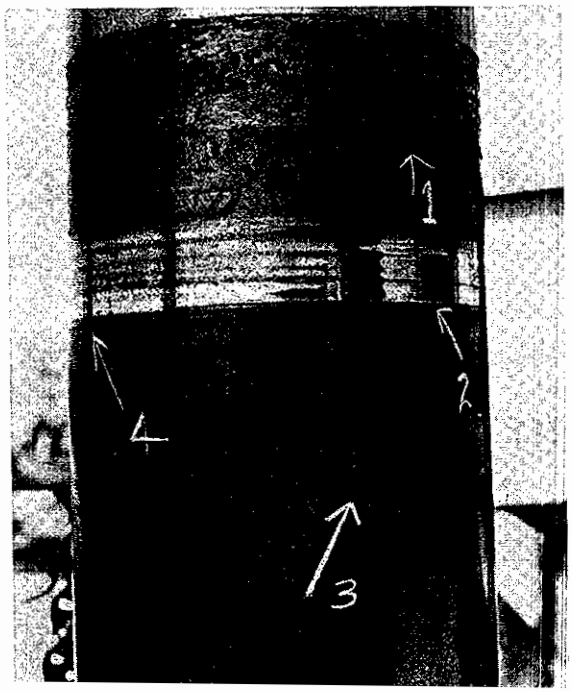
Figure 26. --Girishk Powerplant Unit 1. Turbine shaft--Area 1 is upper packing gland surface. Area between 1 and 2 is upper packing surface. Note pitting in bearing Area 3. Note eccentric wearing at points 2 and 4. This is likely caused by shifting of the shaft center as wear occurs on the shaft and bearing.

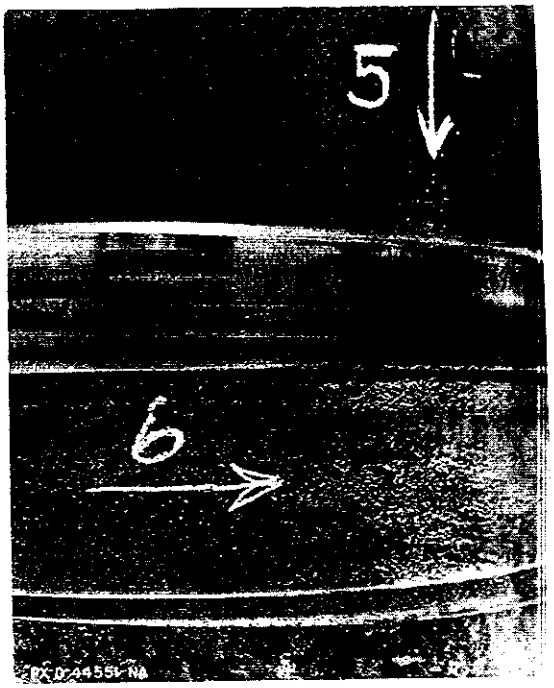
Figure 27. --Girishk Powerplant Unit 1. Turbine shaft showing severe wear. Groove between 5 and 6 was caused by the lower packing which was missing completely at time of disassembly. Area 6 shows galling under the packing gland.

Figure 28. --Girishk Powerplant Unit 1. Turbine shaft--Note eccentric grooving at Area 6. This was caused by the shaft shifting from a forced position after the packing disappeared and wear took place. Double grooving was caused by the packing gland being tightened after packing had disappeared.

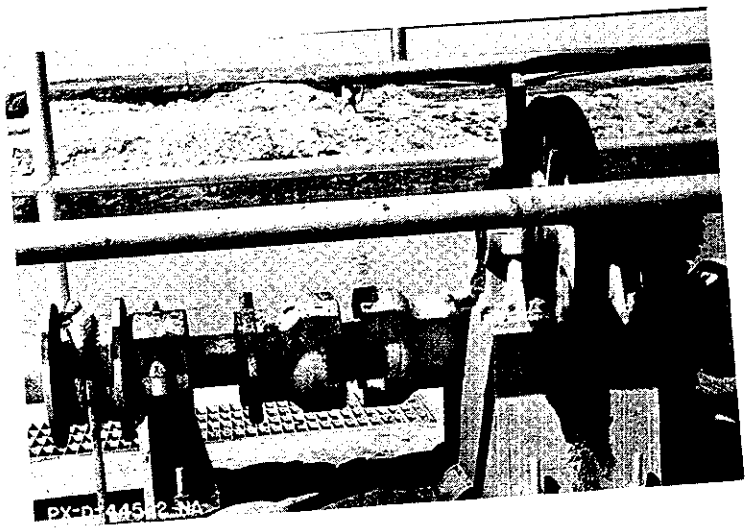
Figure 31. --Boghra Canal Wasteway. The notch-type clutch is used to change from manual to automatic control of the wasteway gates.

Figure 32. --Boghra Canal Checkgate. Wire rope on one checkgate was rusted through.

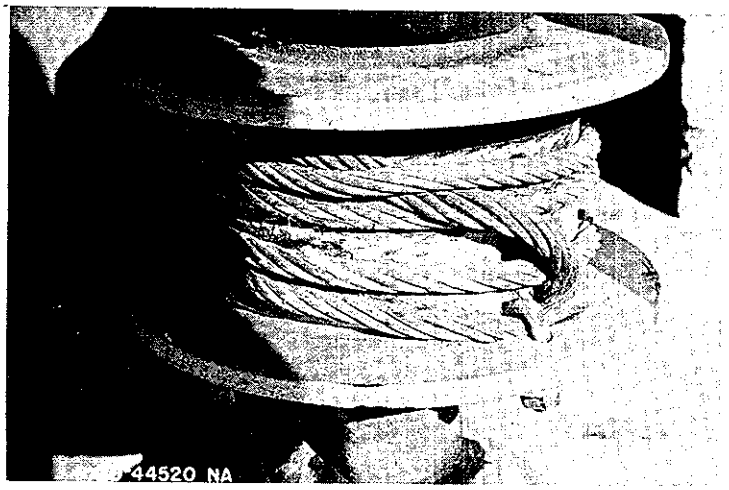
Figure 33. --Boghra Canal Wasteway. Wire rope drum shows type of anchorage and rope winding over loose end.

Figure 34. --Boghra Canal Wasteway. Approach to gate structure bridge has separated 2 to 4 inches at the joint on the first pier.

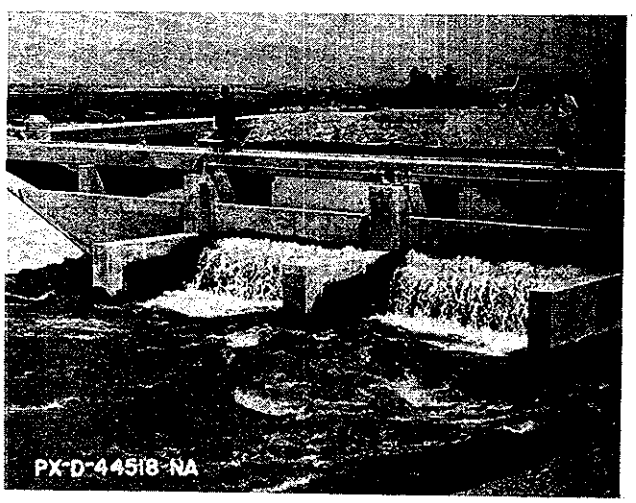
Figure 35. --Canal checkgates. Water flowing through a partially opened top-seal tainter gate which has a corrugated skinplate.

Other similar small structures, such as canal checks, branch canal outlets, and wasteways were examined on the canal system. Many of the small tainter gates (Figure 35) in check structures were top-seal types with corrugated galvanized skinplate. When these gates operate at any intermediate opening, extensive leakage occurs at the top seal because the seal is tight only in the closed position. The amount of leakage is of no consequence, but the continuous flow of water over the back side of the gate is causing considerable deterioration of paint and corrosion of the galvanized skinplates. Many of the hoisting mechanisms have been damaged by heavy traffic passing on narrow bridges over the structures. Small parts of hoisting mechanisms such as nuts, bolts, clamps, and grease fittings are missing.

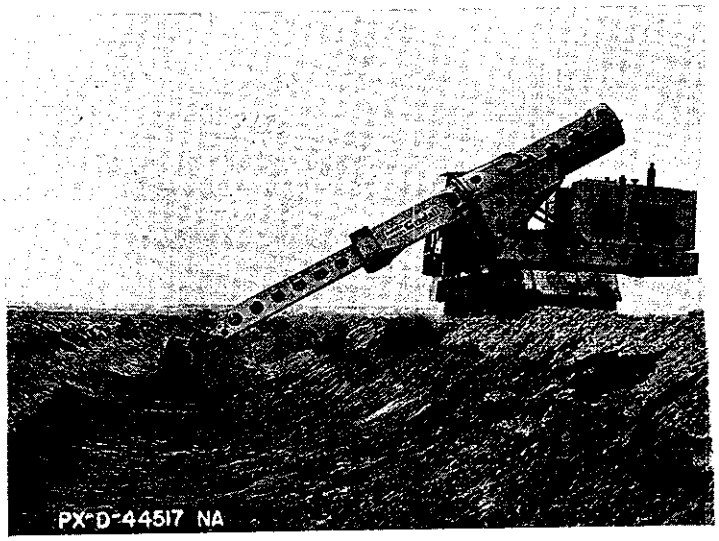
Canals in general are being kept in satisfactory serviceable condition. Heavy equipment such as draglines and a Gradall (Figure 36) is being used in the cleaning and repair work of canals. An objectionable feature of the cleaning operation of canals is that large, tall and irregular piles of material are left on canal banks. This condition is not only unsightly but leaves material where it can easily wash or blow back into the canal. The material also forms mudholes which are destructive to the canal banks and roadways (Figure 37). Some canals have been lined with compacted earth and other portions are being lined with compacted earth for more efficient irrigation operations. Most canal banks have fair roads on at least one side and are used for public traffic (Figure 38). Roads on the main canals are gravelled and in good condition.

Figure 36. --Canal cleaning. A Gradall being used to clean a canal.

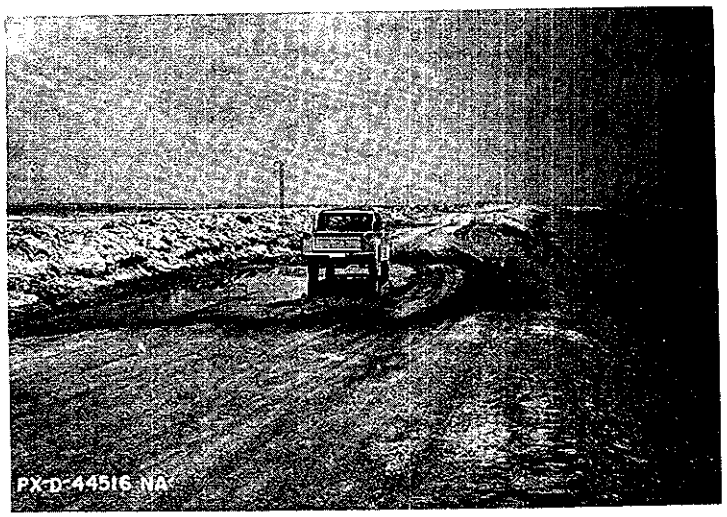
Figure 37. --Canal bank. Mudhole formed on canal roadway by blocking drainage with material removed from canal when cleaning.

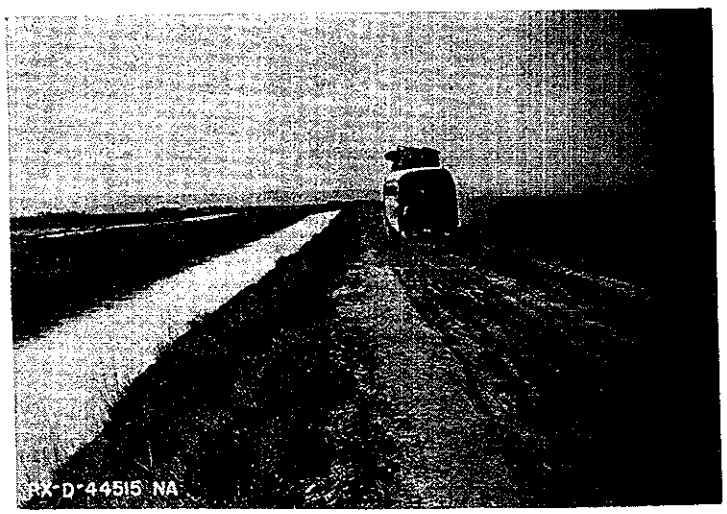
Figure 38. --Canal roadway. Narrow road on the bank of a small canal used for a public highway.
